# INCLUSIONES DE CARBONO BRILLANTE- LUSTROUS CARBON INCLUSIONS

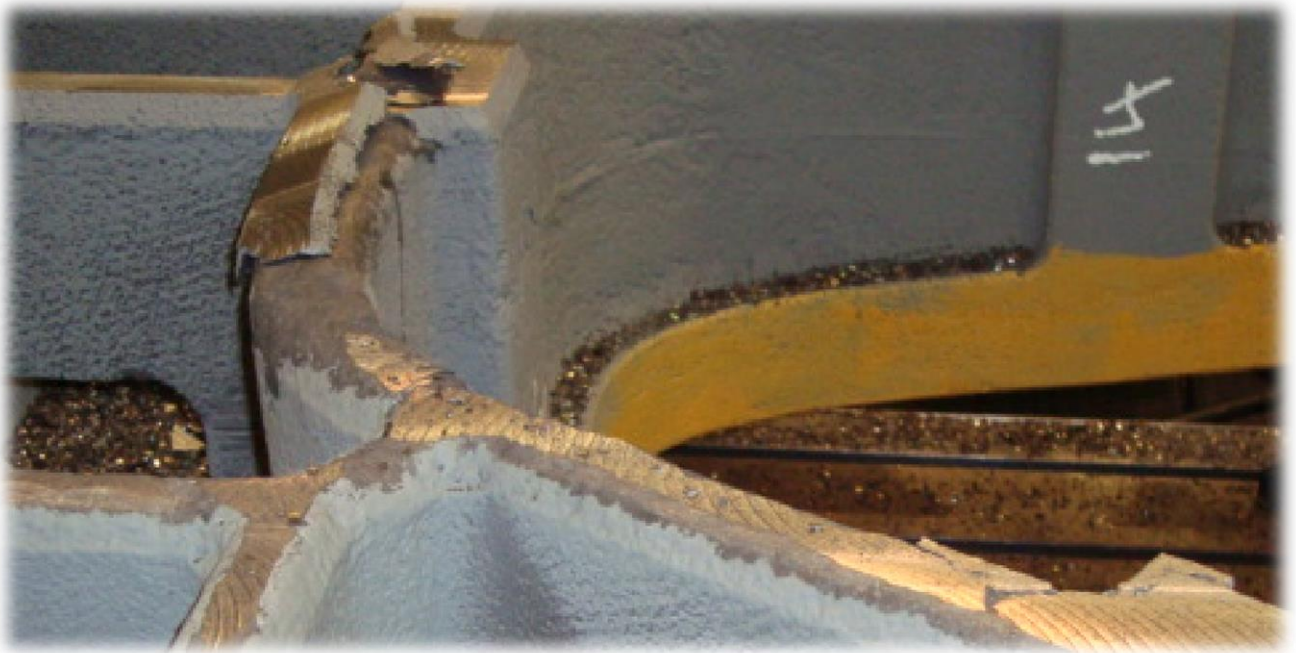
- Presencia de marcas de llenado, inclusiones y/o separaciones del metal debido a una película de carbono impermeable que queda adherida a las superficies de la pieza.

- La superficie del defecto muestra un acabado curvado y brillante, apareciendo una película de carbono brillante depositada en el metal.
- En determinados casos, se forman separaciones de metal y/o inclusiones internas provocadas por el traslado de las películas de carbono brillante como consecuencia de turbulencias o flujos intensos del metal líquido.

- Preferentemente, el defecto se localiza en la parte superior de las piezas (según posición de colada) y en las zonas sometidas a una gran turbulencia.

- Presence of filling marks, inclusions and / or metal separations due to a impermeable carbon film or flakes which gets attached onto the surfaces of the part.
- The defect's surface shows a curved and shiny finish, appearing a bright carbon film deposited on the metal.
- In some cases, separation of metal and / or internal inclusions is formed because of turbulences or liquid metal heavy flows transporting lustrous carbon flakes.
- Usually, the defect is located on top of the parts (casting position) and in areas affected by high turbulence.
- In case of spheroidal casting, they appear together with oxidation and slag inclusions.
- Lustrous carbon inclusions are formed at temperatures above 650 ° C, causing a film left on the silica grains.

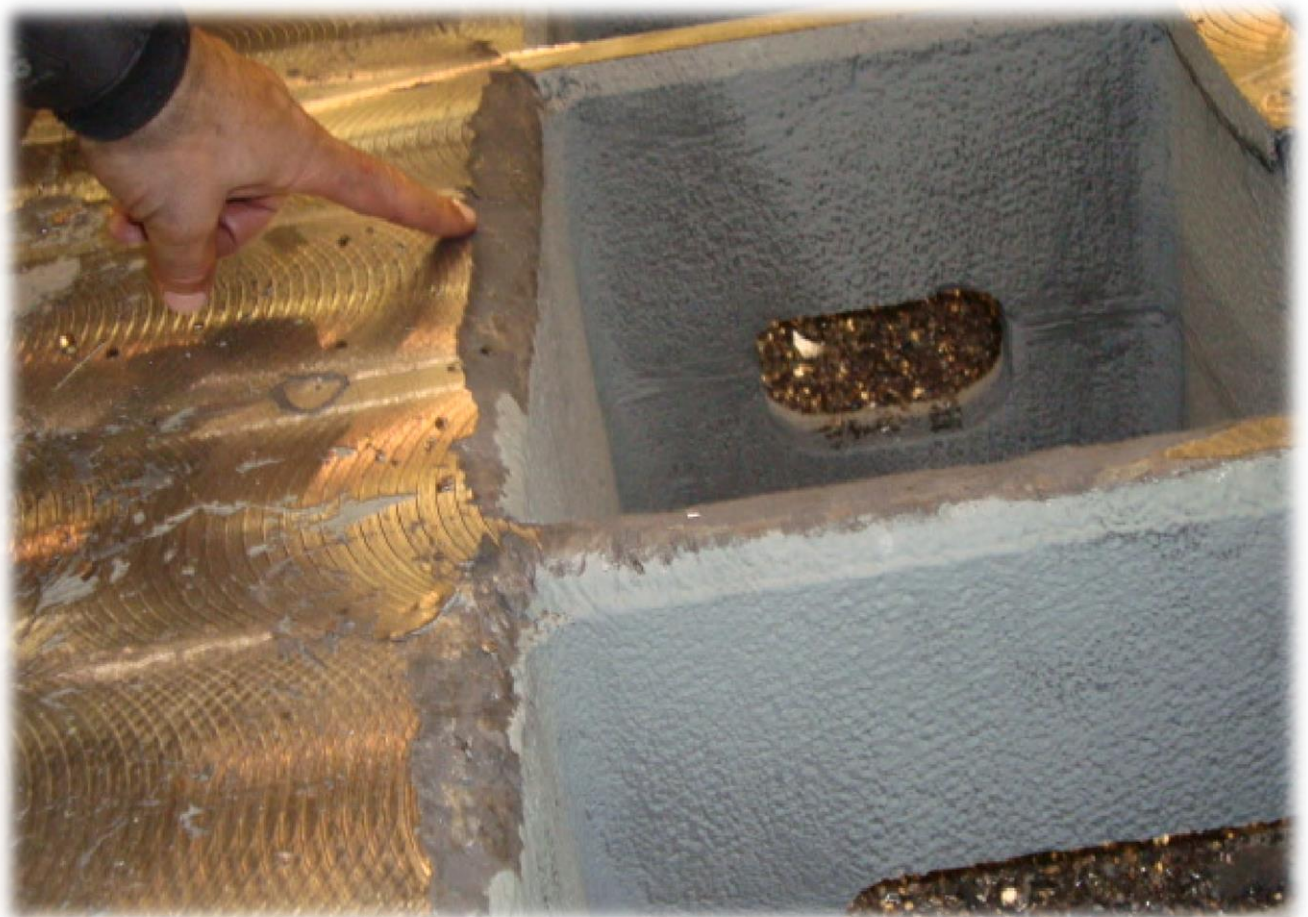
- El exceso de materiales capaces de generar carbono brillante (poliestireno, pintura refractaria), en la arena, permite que este material pueda depositarse incluso antes de que el metal llene completamente las cavidades del molde (moldeo en verde).
- Sistemas de llenado que favorecen la formación de turbulencias en el metal.
- Excesivos tiempos de llenado.
- Temperaturas reducidas de colada y/o utilización de canales de colada muy largos (perdidas de temperatura en el metal).
- Baja permeabilidad en moldes y/o machos.
- Salidas de gas insuficientes en moldes y/o machos.
- Las turbulencias del metal modifican la posición de las láminas de carbono depositadas, generando los pliegues que pueden aparecer en la superficie del defecto.
